1. INTRODUCTION

STS-71 was the Shuttle's first docking mission with the Mir station. Approximately 670 photographs and 24 hours of video of the Mir station were acquired during the rendezvous. This report documents results from several survey-related analysis tasks.

1.1 Overview of Mir Photo/TV Survey

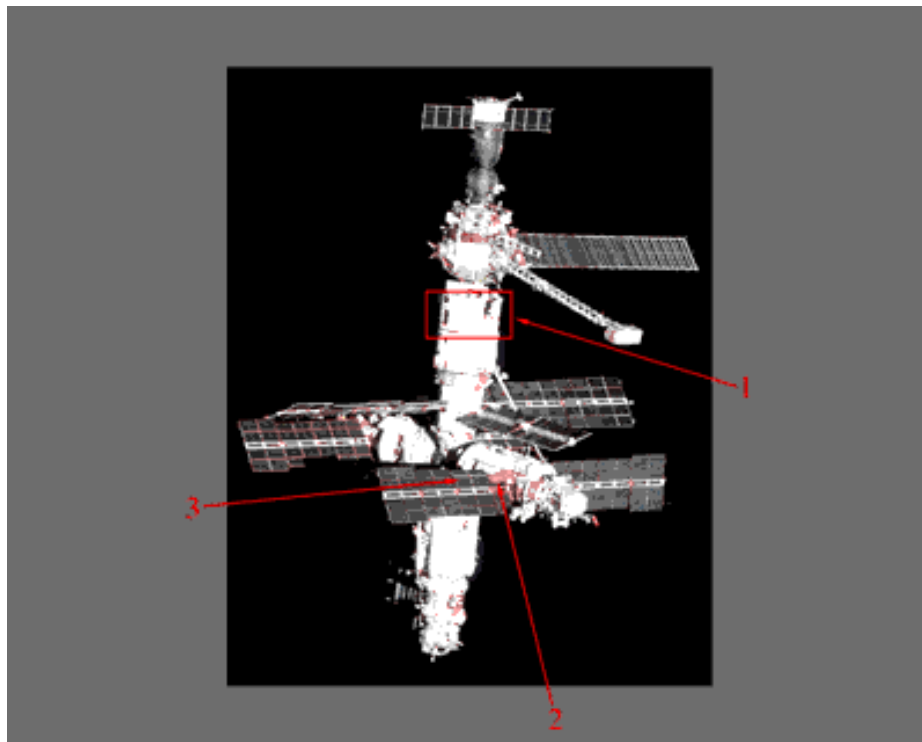
Figure 3-A Overview Fly-around View

Item 1 identifies the upper section of the Mir Base Block where discoloration is observable. This discoloration appears to follow along the seams of adjacent panels. Similar observations were made on STS-63 for the opposite side of the Base Block.

Items 2 and 3 identify damaged panel sections of a Kvant-2 solar array. The panel labeled 2 has been folded backwards upon itself. Item 3 refers to the adjacent panels that are bowed in the opposite direction.

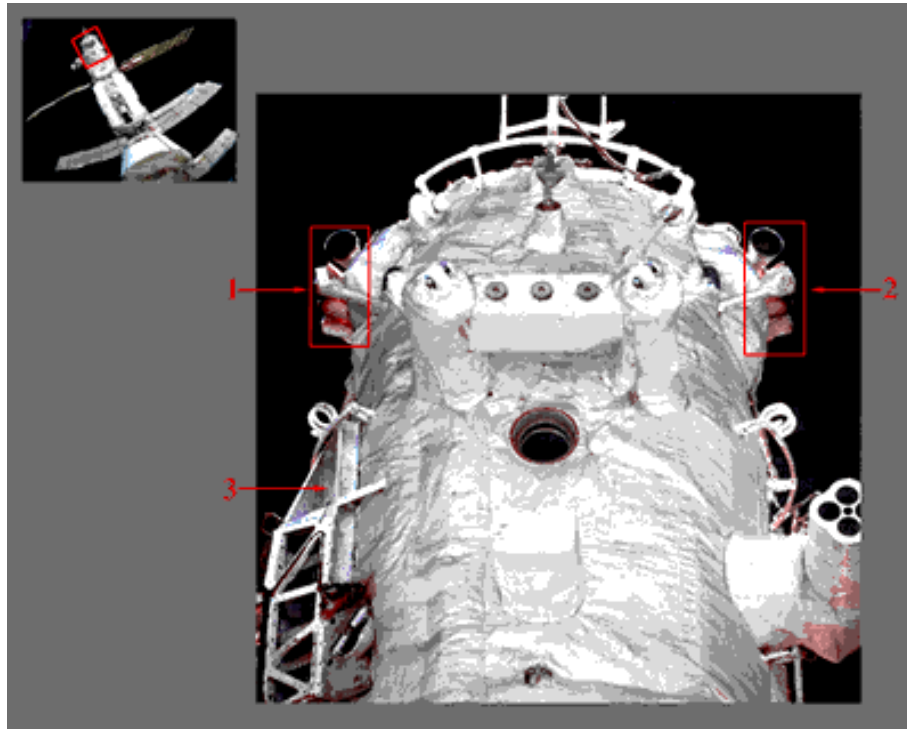
Figure 3-B Kvant-2 Thrusters and Support Structure

Items 1 and 2 identify areas around the attitude control engines. All the visible nozzles with this configuration on the Kvant-2 module seem to show some degree of discoloration. Russian investigators have attributed this type of discoloration to propellant residue. The identification of these areas will help in the analysis of plume dynamics on the International Space Station.

Item 3 identifies a discolored support structure. Some of the blankets covering large surfaces displayed spots and/or blotchy patterns. Discoloration observed on this blanket appeared to be concentrated in an area near the structural interface.

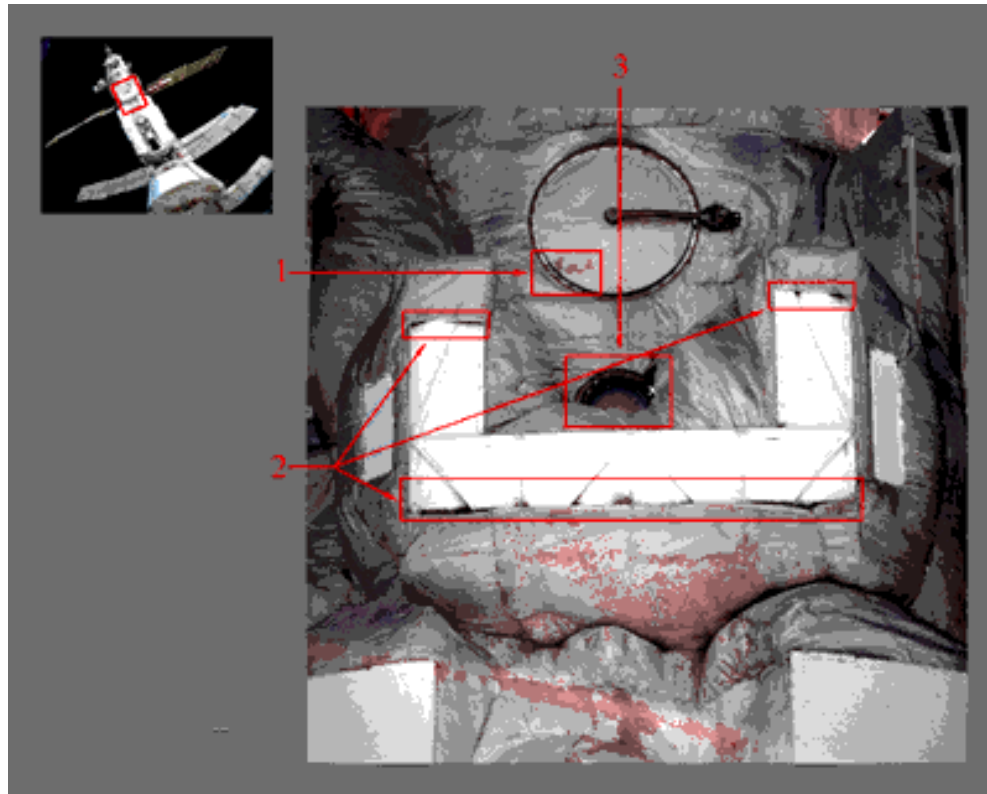
Figure 3-C Kvant-2 Airlock Section

Item 1 identifies an area of discoloration on the observation port cover.

Item 3 identifies an observation port window partially blocked by a blanket. This may be due to loose folds in the material that have propagated since the original deployment.

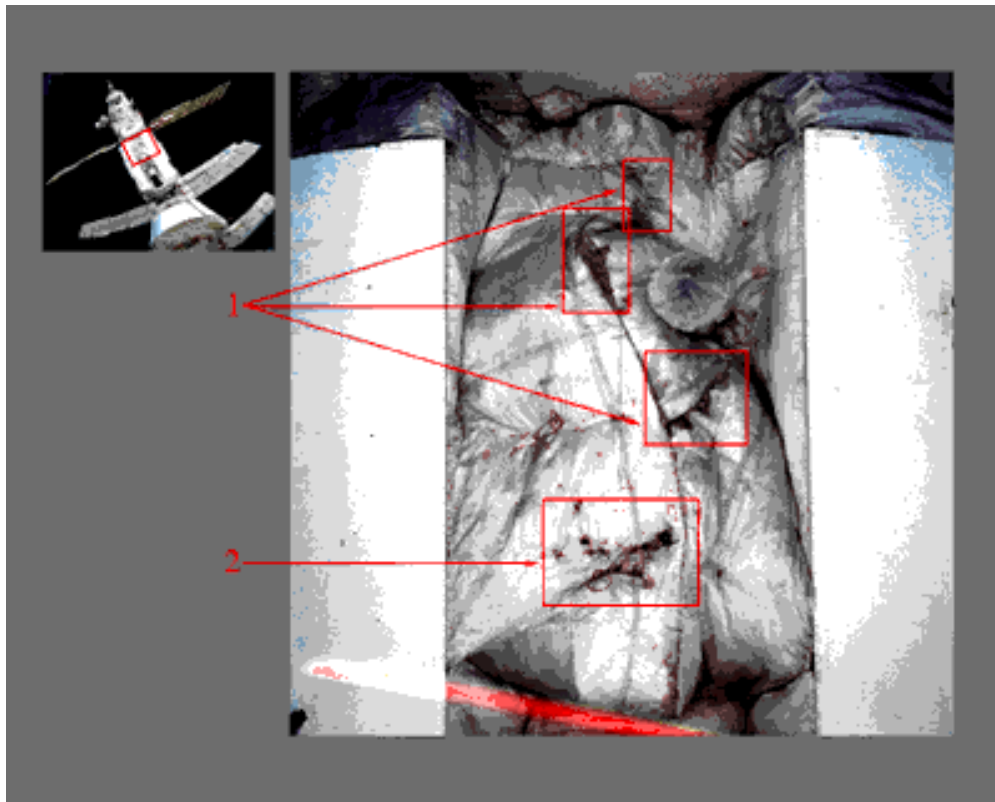
Figure 3-D Kvant-2 Blanketed Area between Radiators

Item 1 exhibits discolored areas on the blanketed area between the radiators.

Item 2 identifies possible blanket damage. The particular areas of interest seem to reveal some underlying structure(s). This indicates holes or openings that are evident in the blanket.

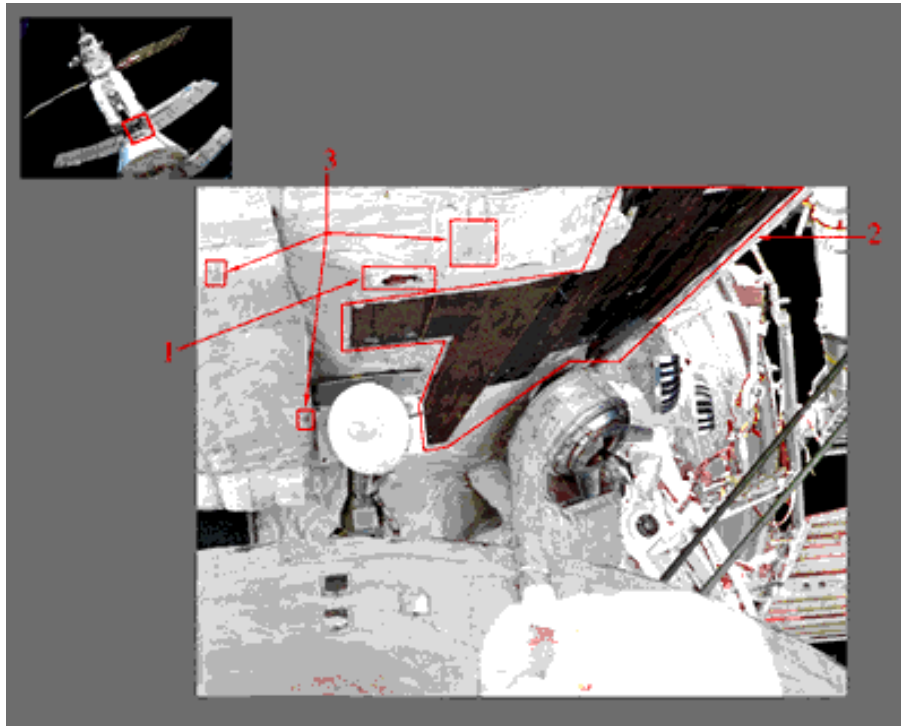
Figure 3-F Kvant-2 Conical Section

Item 1 identifies a section of blanket which appears to be torn. The length of this tear was measured to be 12 cm.

Item 2 highlights an area on the Kvant-2 endcone. A determination has not yet been made as to whether the region is actually missing thermal protection or is intentionally kept clear. The approximate area of this feature is 1460 cm².

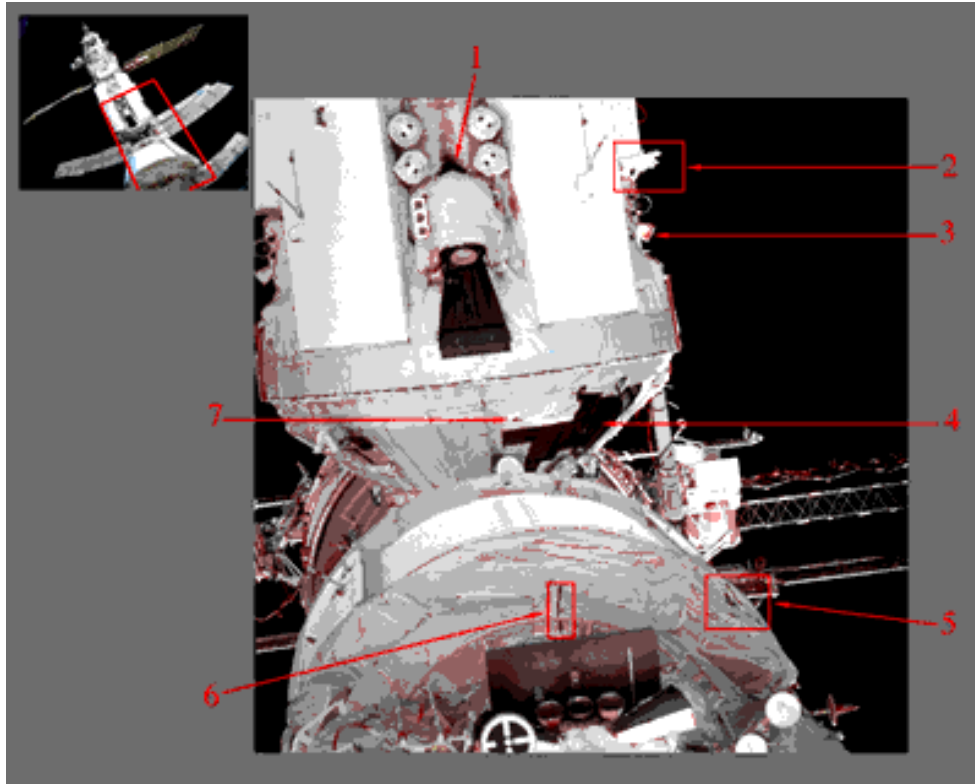
Figure 3-G Expanded View of Kristall / Kvant-2

Item 1 is a dark discoloration in the crevasse behind the positioning and docking engines on the Kvant-2 module. Closer scrutiny of this area during the ground-controlled video survey indicated that the discoloration was not due to shadowing.

Item 4 points to the barren area observed on the conical section of the Kvant-2 module (discussed in Figure 3-F).

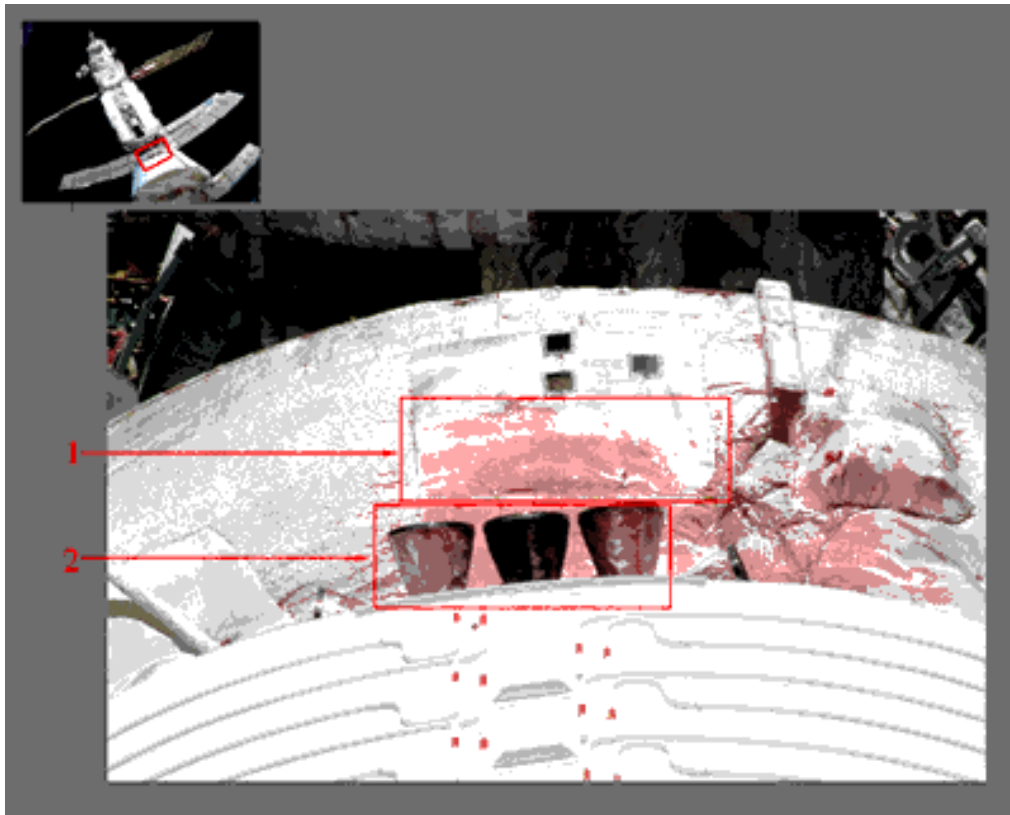
Figure 3-H Upper Kristall Thrusters

Item 1 points out discoloration on the blanketed area above the attitude control engines. Scattered white dots can also be seen in this region. Investigators have attributed this type of discoloration to propellant residue.

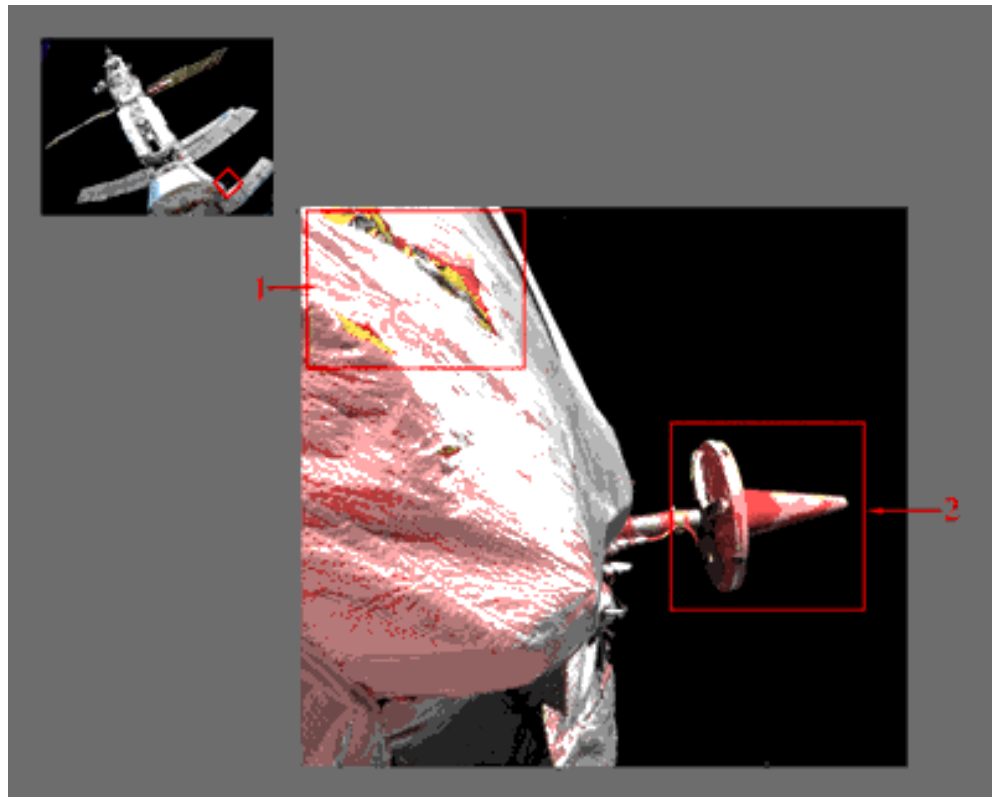
Figure 3-I Close-up of Kristall Module and Kurs Antenna

Item 1 is a view of two tears on the thermal protection blanket area adjacent to the Kristall radiators. These tears were measured to be 17 cm and 9 cm in length. Additional measurements of adjacent tears are noted in Appendix A.

Item 2 highlights discoloration of the Kurs antenna. Possible sources for the cause of this discoloration are propellant residue or degradation due to atomic oxygen.

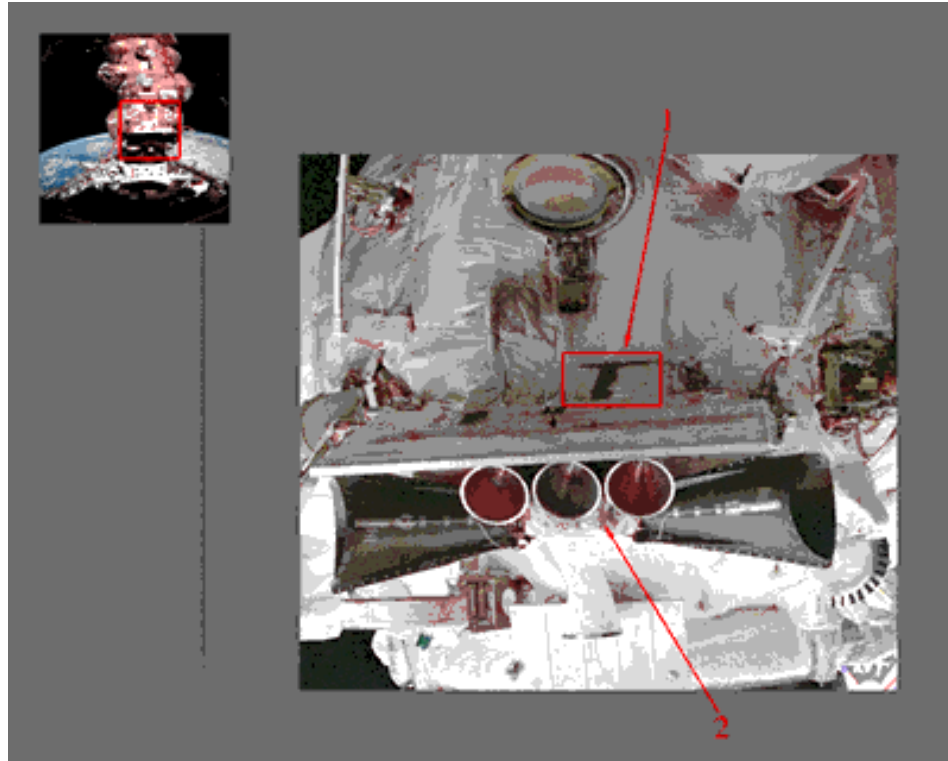
Figure 3-J Lower Kristall Thrusters

Item 1 points to a dark discoloration on the blanket material above the blast deflection plate. Russian investigators will be contacted to determine whether this could be a result of leaking propellant.

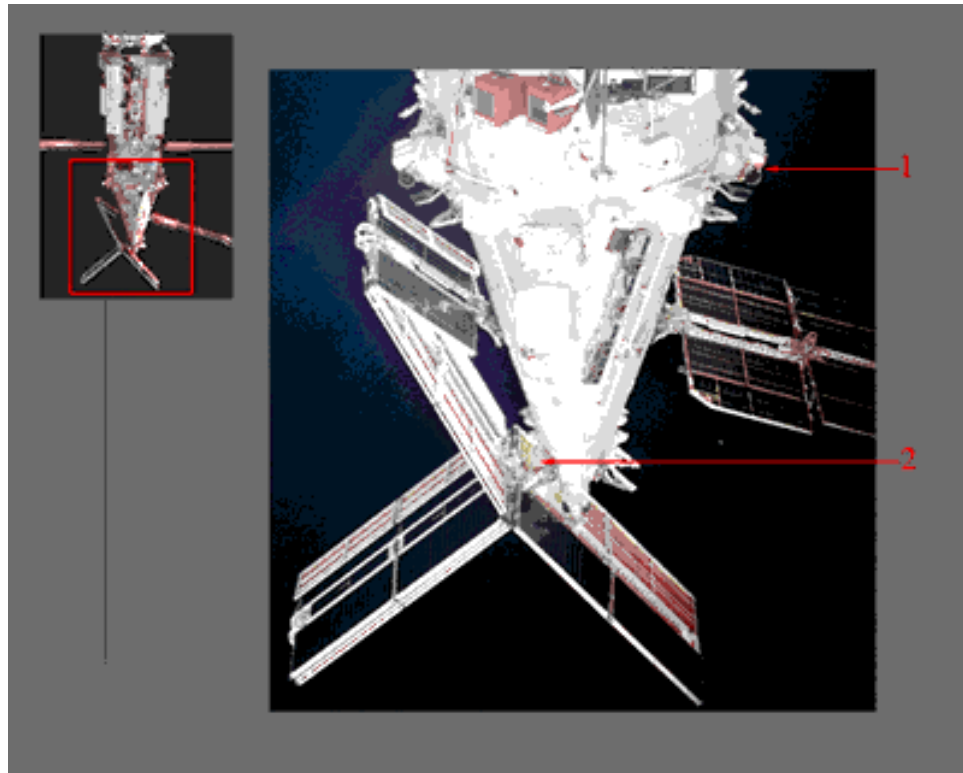
Figure 3-K Spektr Nose Cone

Item 1 identifies slight discoloration on the attitude controls engines. According to Russian investigators, this type of discoloration is common for engine nozzles and surrounding areas.

A restraining bolt inhibited proper deployment of one Spektr solar array. Item 2 shows the array as it was seen during STS-71. Image survey data of this area gathered during the mission was forwarded to the Russians. This array has since been repaired during an EVA by the Mir-19 crew.

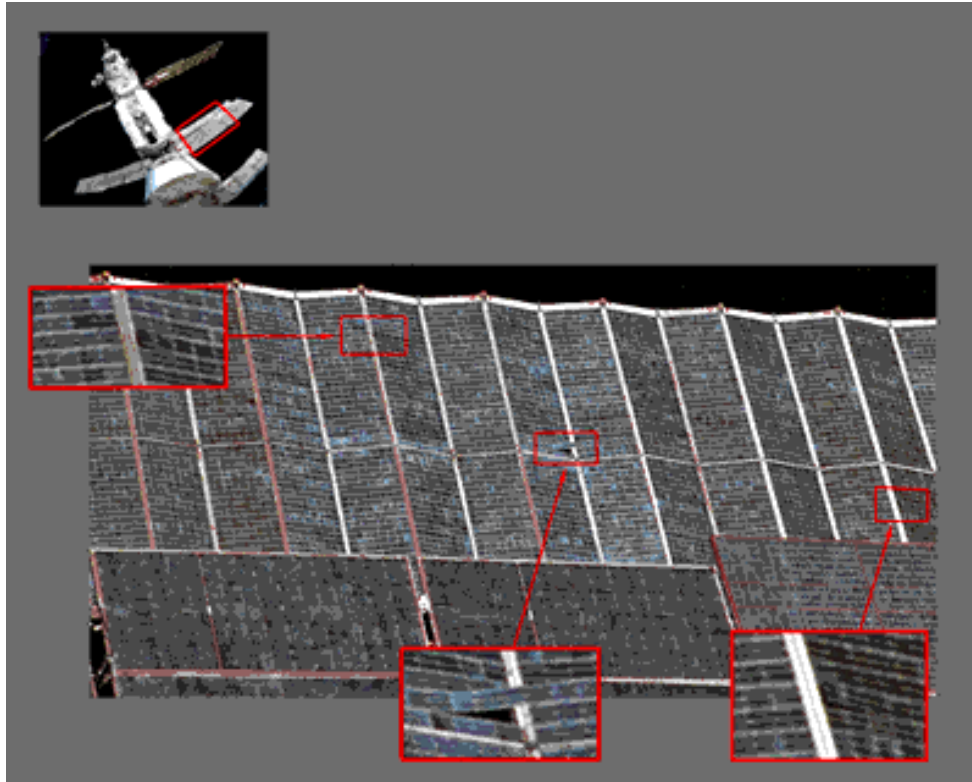
Figure 3-L Kvant Solar Array

Item 1 identifies three prominent areas where solar cells are seen detaching from the Kvant array. Six such areas of cell detachment were located and another 20 instances of loosely attached cells or possible damage were noted. This anomaly has not been seen on the other Mir arrays (such as those on the Base Block or Kvant-2.)

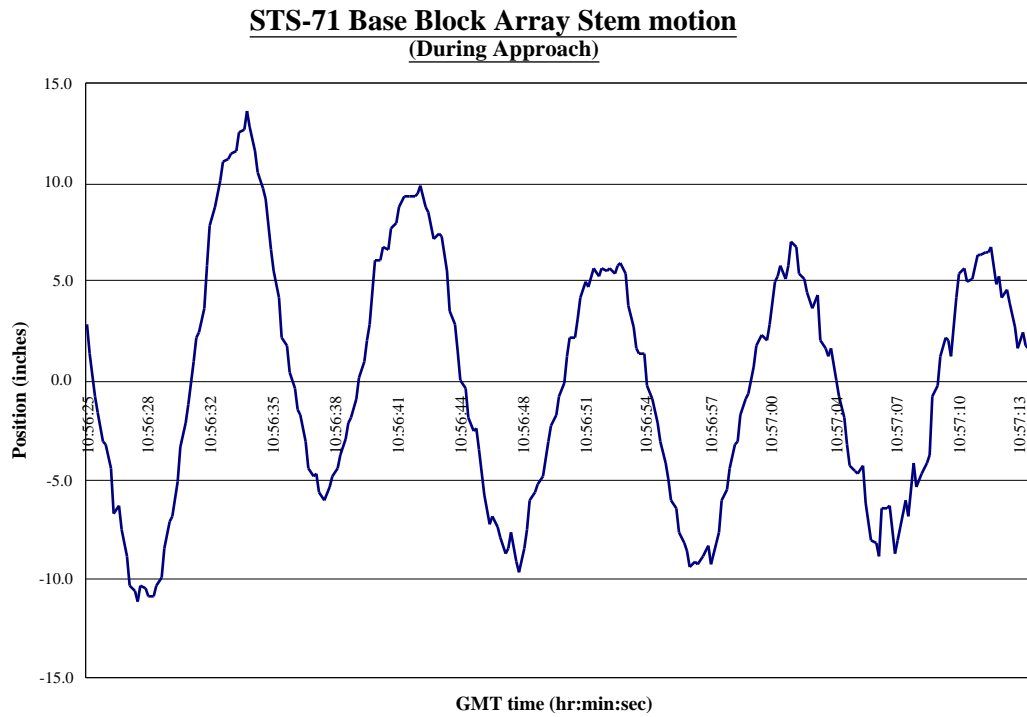
Figure 5 - C Base Block Array Stem Motion

Figure 5-C shows this motion as a function of GMT time. Figure 5-D plots the corresponding frequency of oscillation. Analysis of this motion indicated a maximum peak-to-peak magnitude of about 24 inches (+/- 20%) and a dominant frequency of 0.11 Hertz.

Analysis of this data suggests that the Mir Base Block solar panel stems and arrays are in a location such that attitude firings do impinge upon them. There are other factors that could have contributed to this motion. Start and stop forces induced by rotating panels may have contributed to the first visible motion sequence. Additionally, during the latter part of this time sequence, it appeared as though all the other arrays continued to rotate while those on the Base Block appeared to stop.

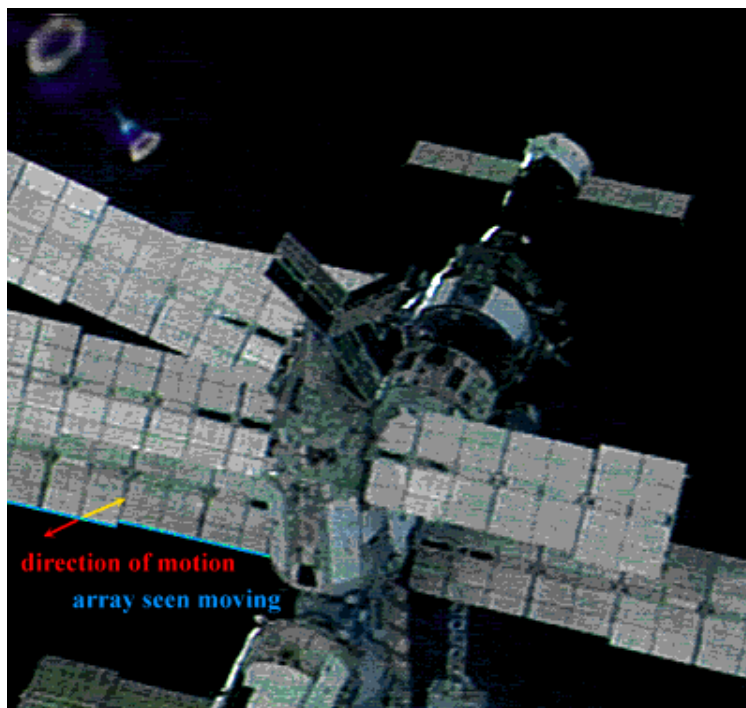
Figure 5-E PLB Camera 'B' View Showing Base Block Panel Motion

Motion of the lower panels on the opposite Base Block solar array (SP #2) was visible several minutes later. The payload bay camera 'B' scene appeared to shake slightly. Minor vibration of a payload bay camera field-of-view is usually indicative of a Shuttle Reaction Control System (RCS) thruster firing. An examination of Shuttle RCS data between 11:07:19 and 11:08:19 GMT suggested that pulses fired from the L2D/L3D and R2D/R3D thrusters appeared to coincide with this motion. Upon closer examination, however, array motion preceded the first of these pulses by about a second. This implied that a different source (possibly Mir thrusters hidden from the camera field-of-view) was the cause of this motion.

Figure 5-E depicts the payload bay camera 'B' field-of-view when the Base Block solar array panel motion was visible. The magnitude of this oscillation could not be measured due to the oblique camera angle relative to the direction of motion. However, a plot displaying frequency of the motion is shown in Figure 5-F.
